## Radon Inspection Report

Bldg. Type: Residential Single Family

Type: Pre-Mitigation

### Test Result: Pass

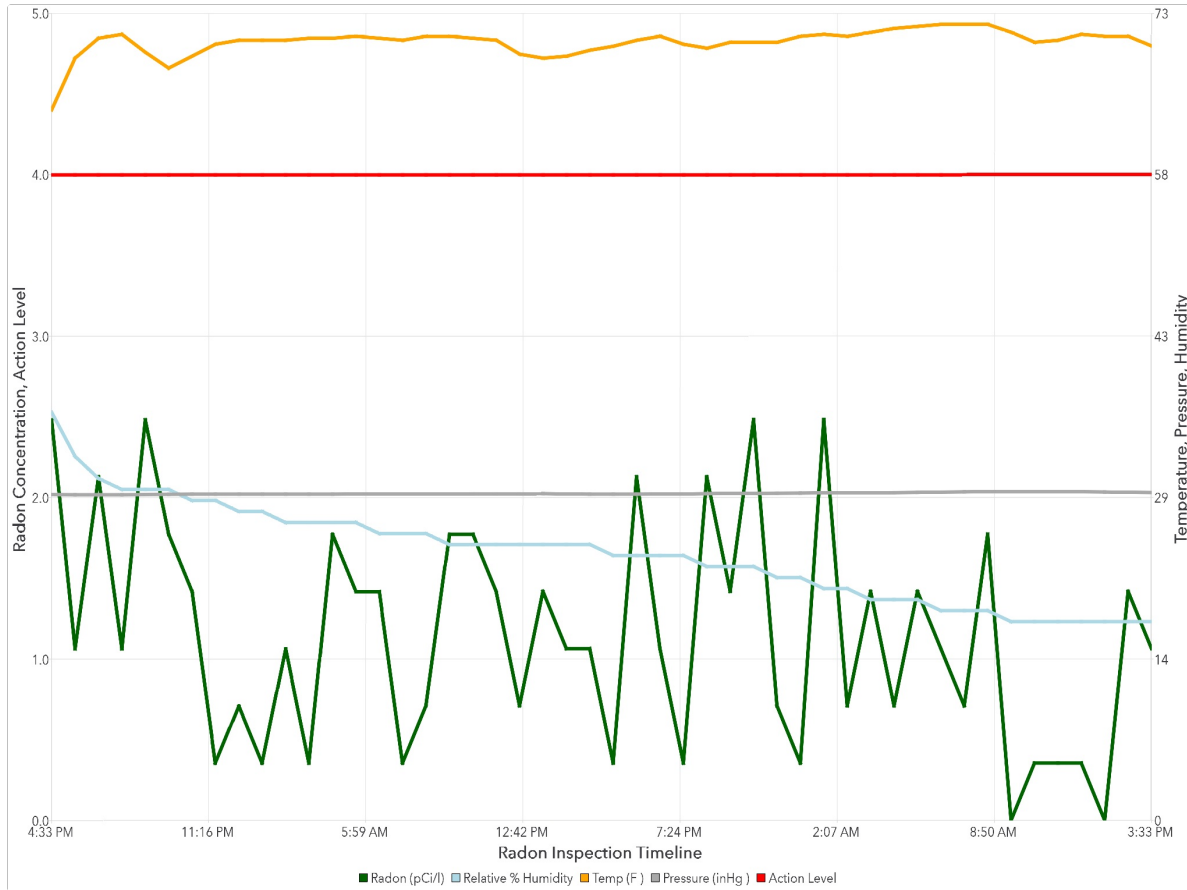
## Radon Inspection Chart

**1.1 pCi/l**

<u>CRM Location:</u>	<u>Start:</u>	<u>Stop:</u>	<u>Interval:</u>	<u>Duration:</u>
Basement	03/10/2022 03:33 PM	03/12/2022 03:33 PM	1 hr	48 hr
	<u>Min:</u>	<u>Max:</u>	<u>Average:</u>	<u>Measurement Units:</u>
Radon Concentration:	0.0	2.5	1.1	pCi/l
Temperature	64.4	72.1	70.5	F
Humidity	18	37	24	%
Pressure	29.52	29.79	29.62	inHg
